Lead Free Solder and Flex Cracking Failures in Ceramic Capacitors

N. Blattau, D. Barker, and C. Hillman
CALCE Electronic Products and Systems Center
Building 89, Room 1103
University of Maryland
College Park, MD 20742
Tel.: (301) 405-5323
Fax: (301) 314-9269

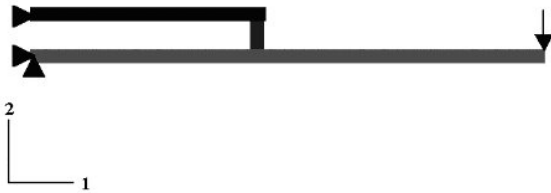
Figure 4: FEA beam model of 0805 capacitor

A beam structure is used to approximate the 0805 capacitor mounted to a PWB. The FEA model (shown in Figure 4) uses material properties listed in
